# Environmental assessment of thinning with Bracke C16c Smallwood version

# Smallwood

✔ To quantify and compare tree and soil damages and thinning emissions of boom corridor thinning and selective thinning in small-diameter-tree stands of various characteristics in Sweden, Finland, Slovenia, and Spain.

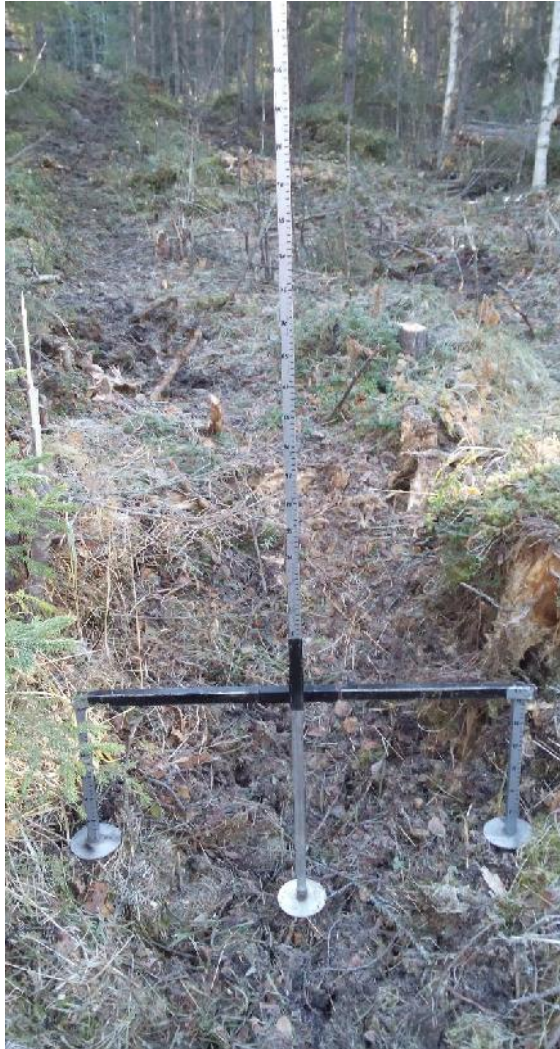
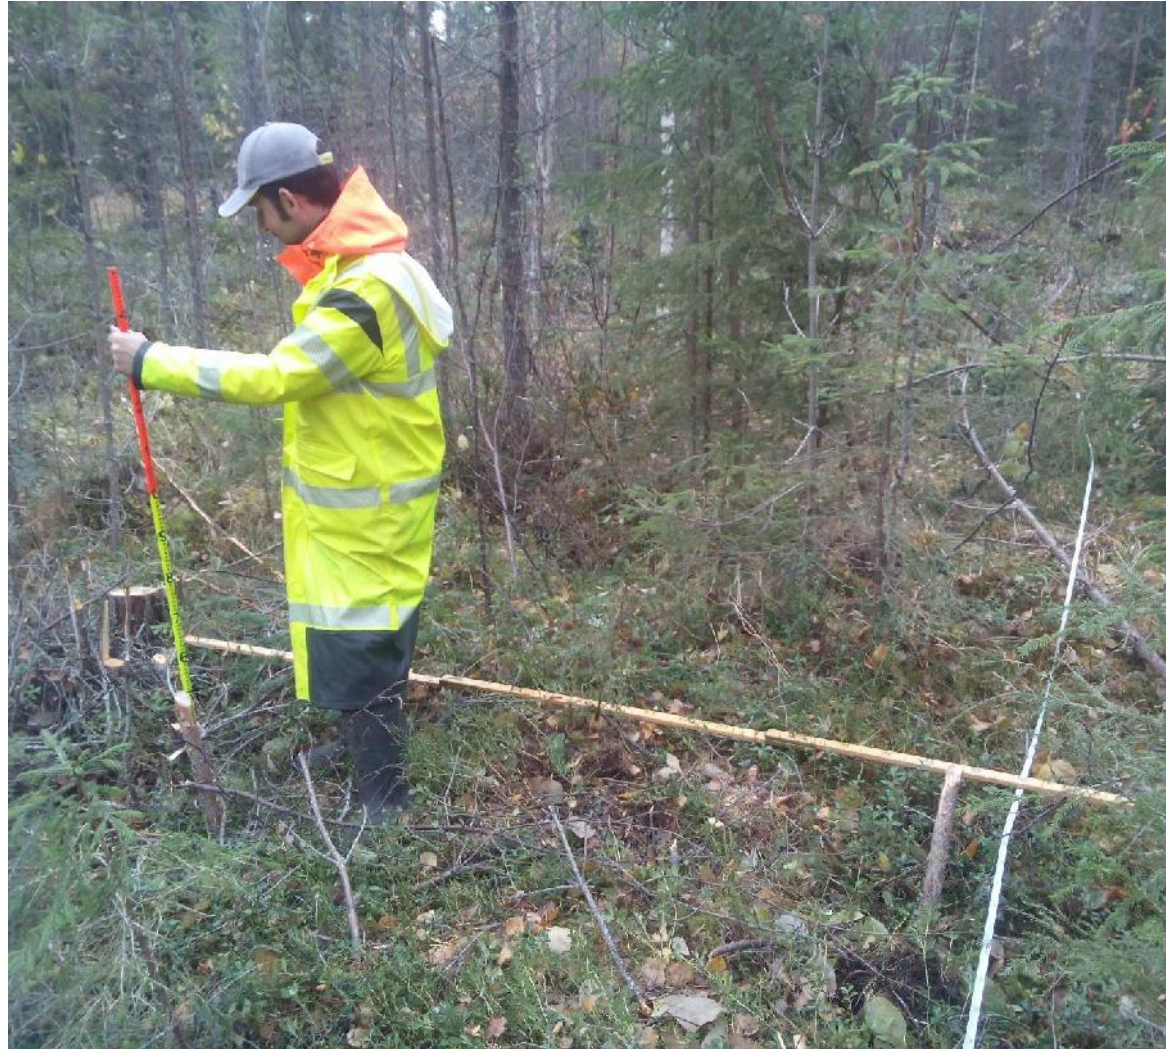
Soil damages (rutting  $> 10$  cm depth) were measured along the strip road before forwarding

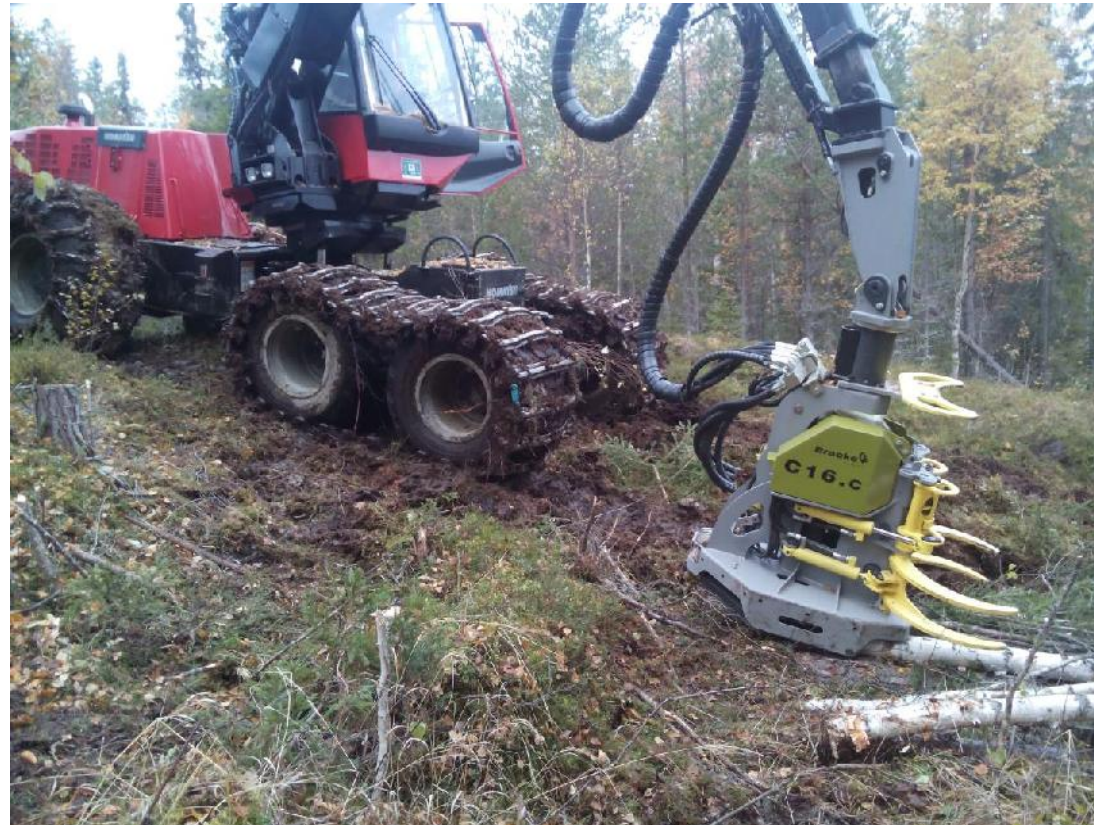
Harvester fuel consumption was estimated by the engine management computer. Data was taken for each study unit.

A Life cycle perspective was used to calculate the environmental impacts of the harvesting process.

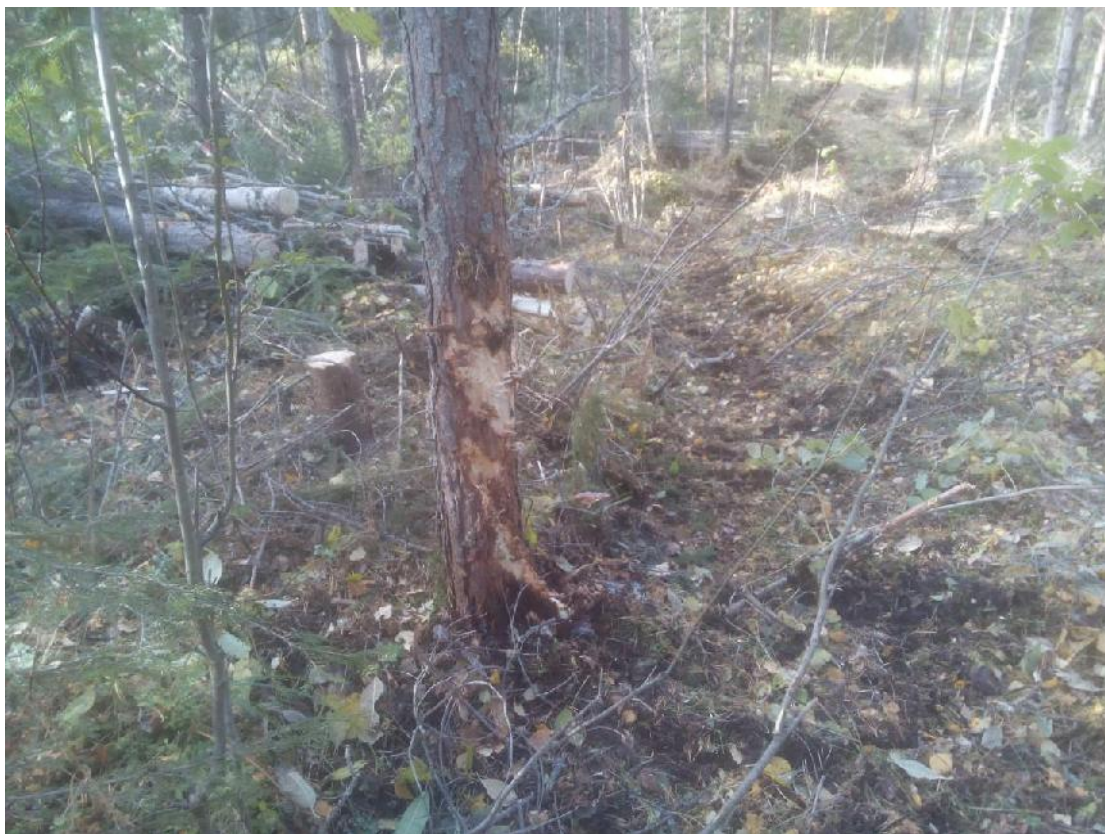
## Damaged tree number per working method

Working method	Number of damaged trees / 100 m strip road <u>after thinning</u>			
	Sweden	Finland	Slovenia	Spain
Boom C.	4.4 (4.0)	2.3 (2.7)	6.6 (4.2)	2.3 (2.2)
Selective	5.1 (2.2)	4.3 (5.3)	12.0 (5.1)	2.5 (2.6)

Values are average per study unit and working method with standard deviation in brackets.

**The difference between working methods was statistically significant at 90% confidence level (p-value=0.069)**

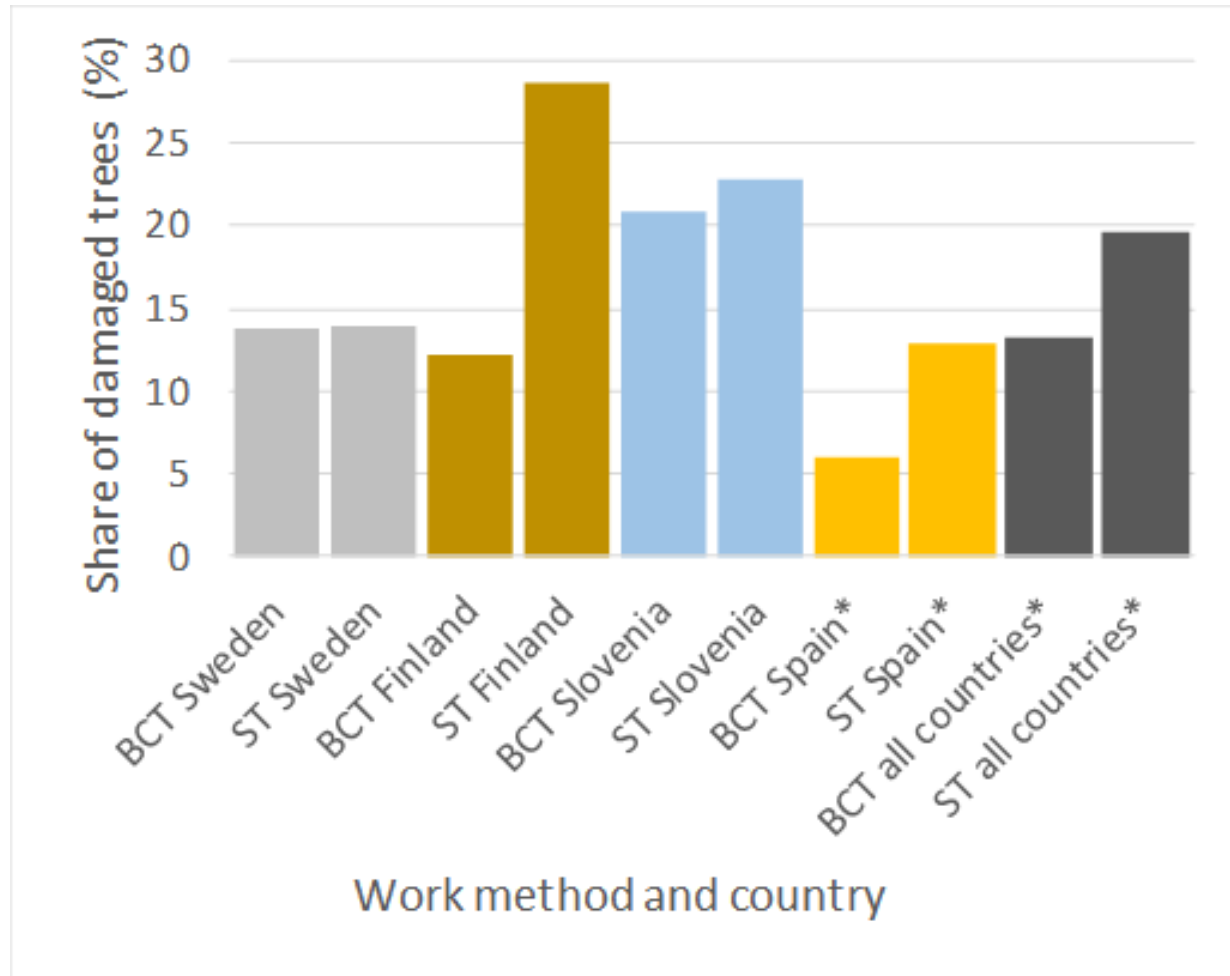
# Share of damaged trees in relation to remaining trees (DBH $\geq 7$ cm) after forwarding

The damaged tree number after forwarding was 32% significantly lower in BCT (p-value = 0.041)

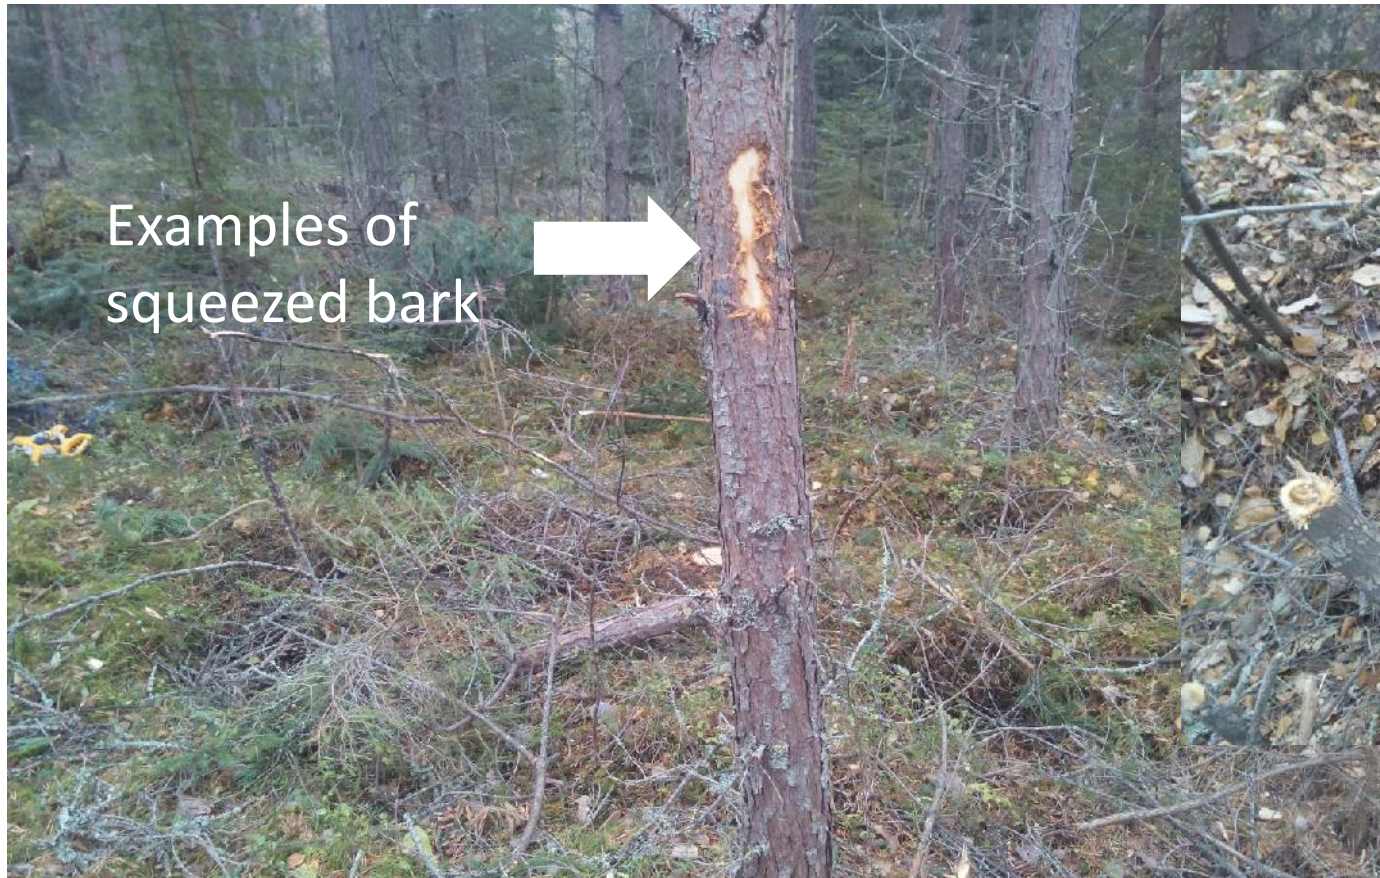
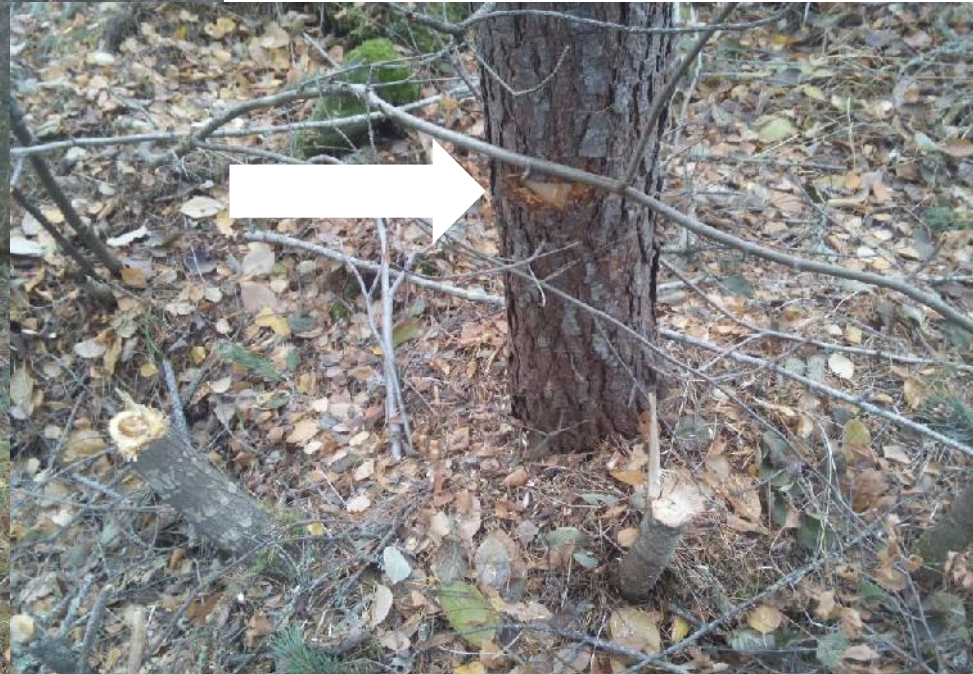
# Damage characteristics

In Sweden and Finland most of the damages were "squeezed bark", while "scratched bark" and "wood damage" were the most common damages in Slovenia and Spain, respectively.

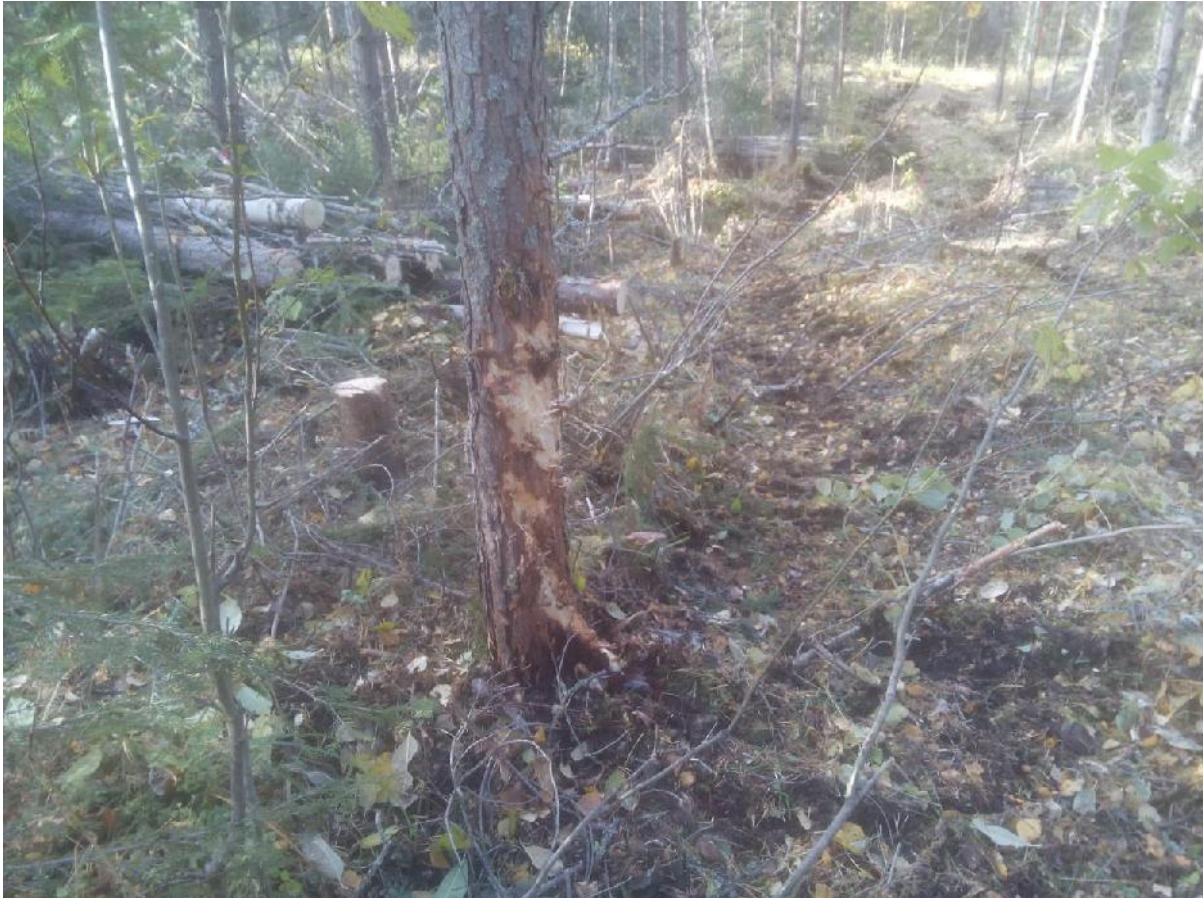
The location of the damages along the tree varied in height between countries and working methods. However, in Finland and Spain most of the damages were lower than 30 cm for both working methods.

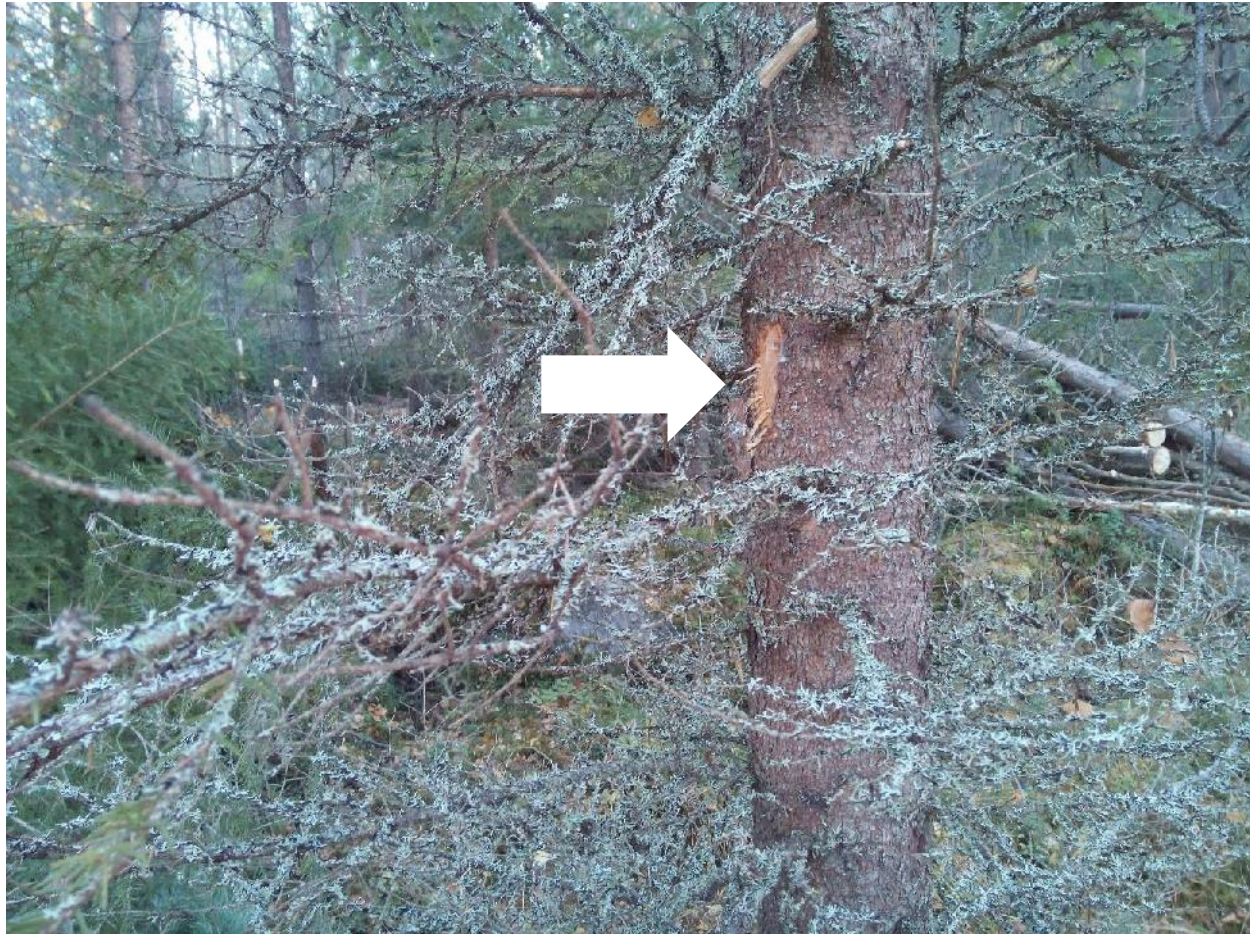
Most of the damages were smaller than 50 cm<sup>2</sup> in the four countries and for both working methods, with the exception of ST in Slovenia, which showed a larger amount of damages bigger than 200 cm<sup>2</sup>.

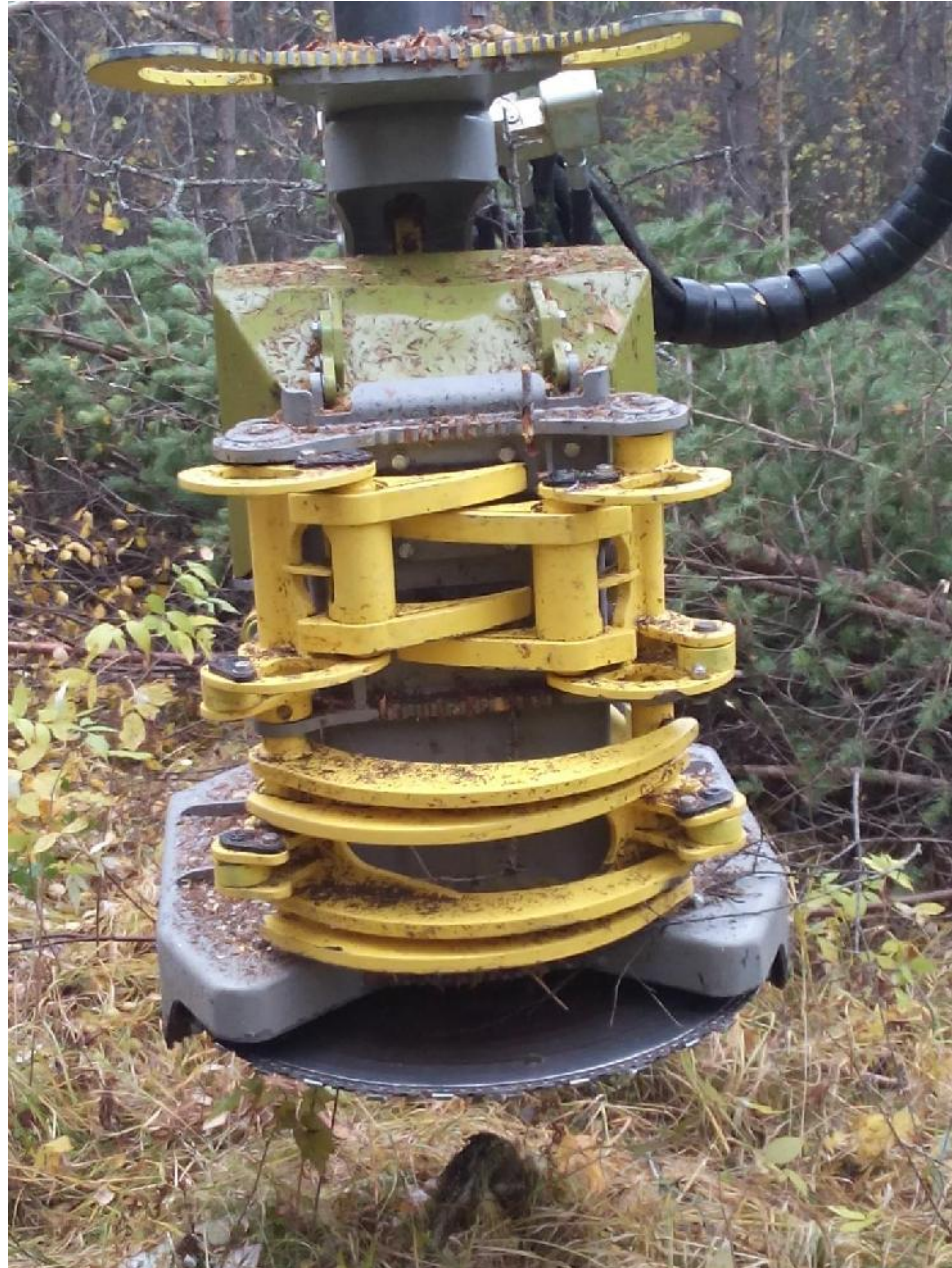
The main **damage cause** was the **harvester head** movement for all countries and for both working methods.

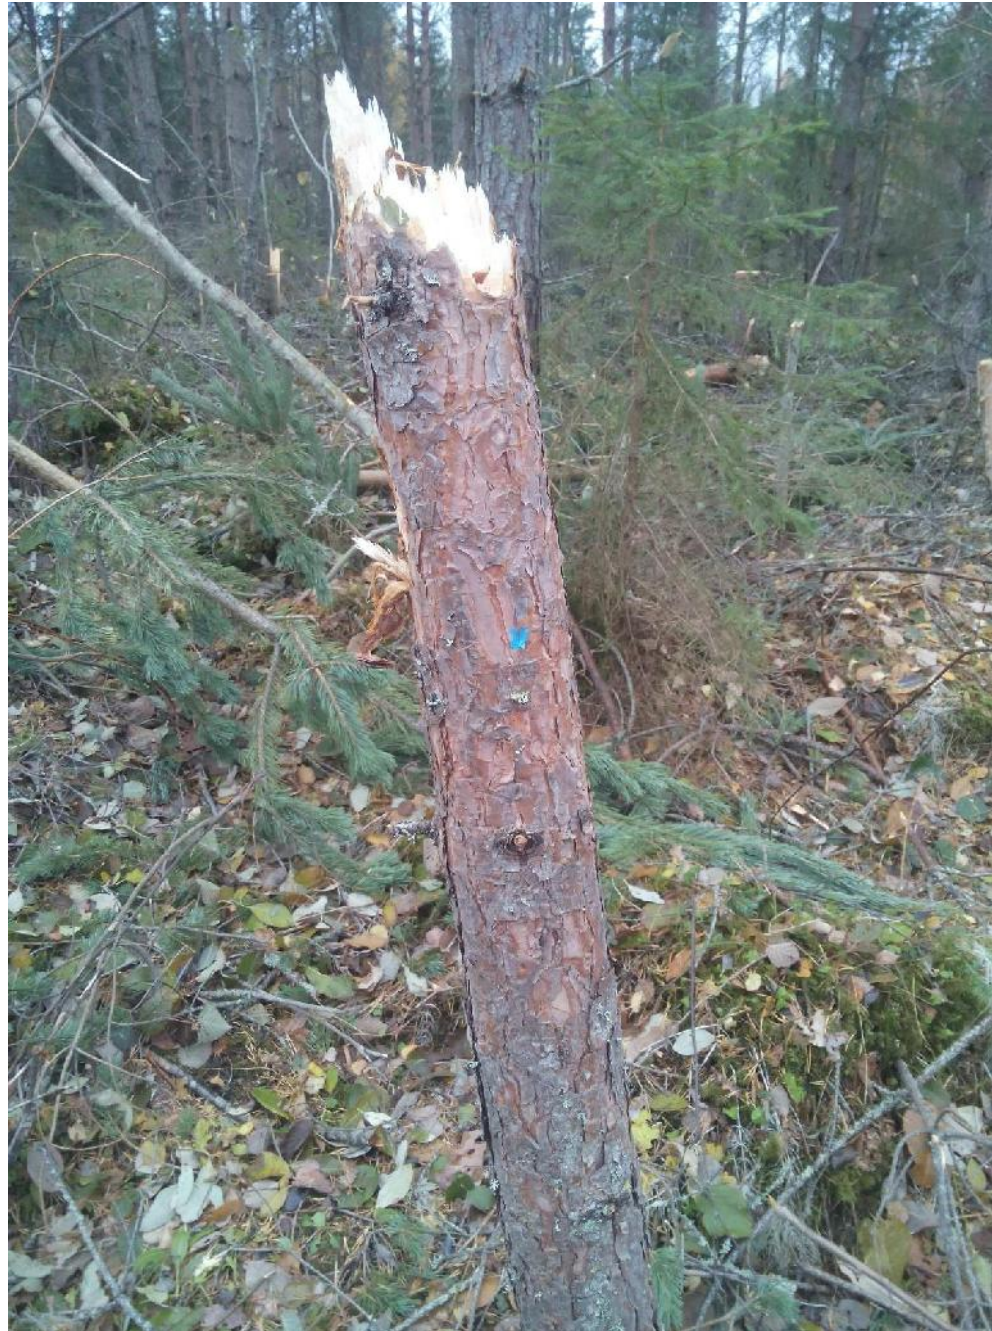
**The destroyed tree number was very low in all countries and for both working methods (between 0 and 0.3 trees per study unit)**

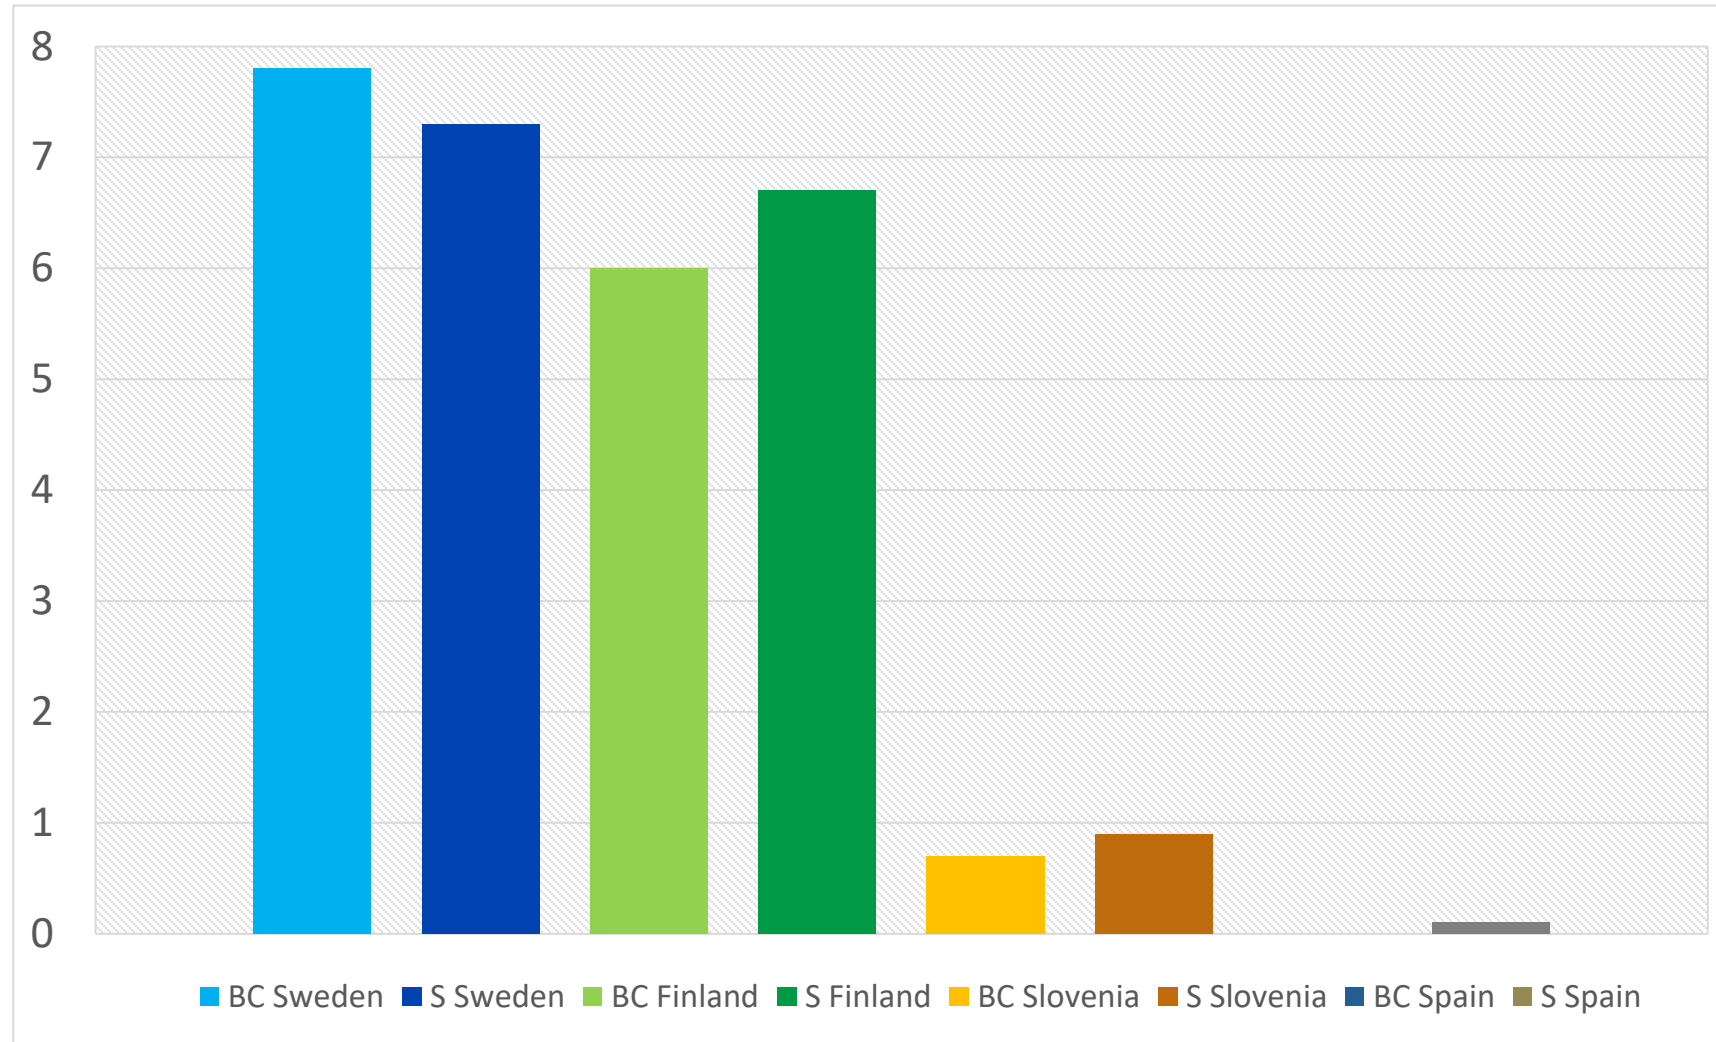
# Soil damages m/100 m strip road

**There was no statistical difference between the working methods in the damage characteristics, soil damages and stump height.**

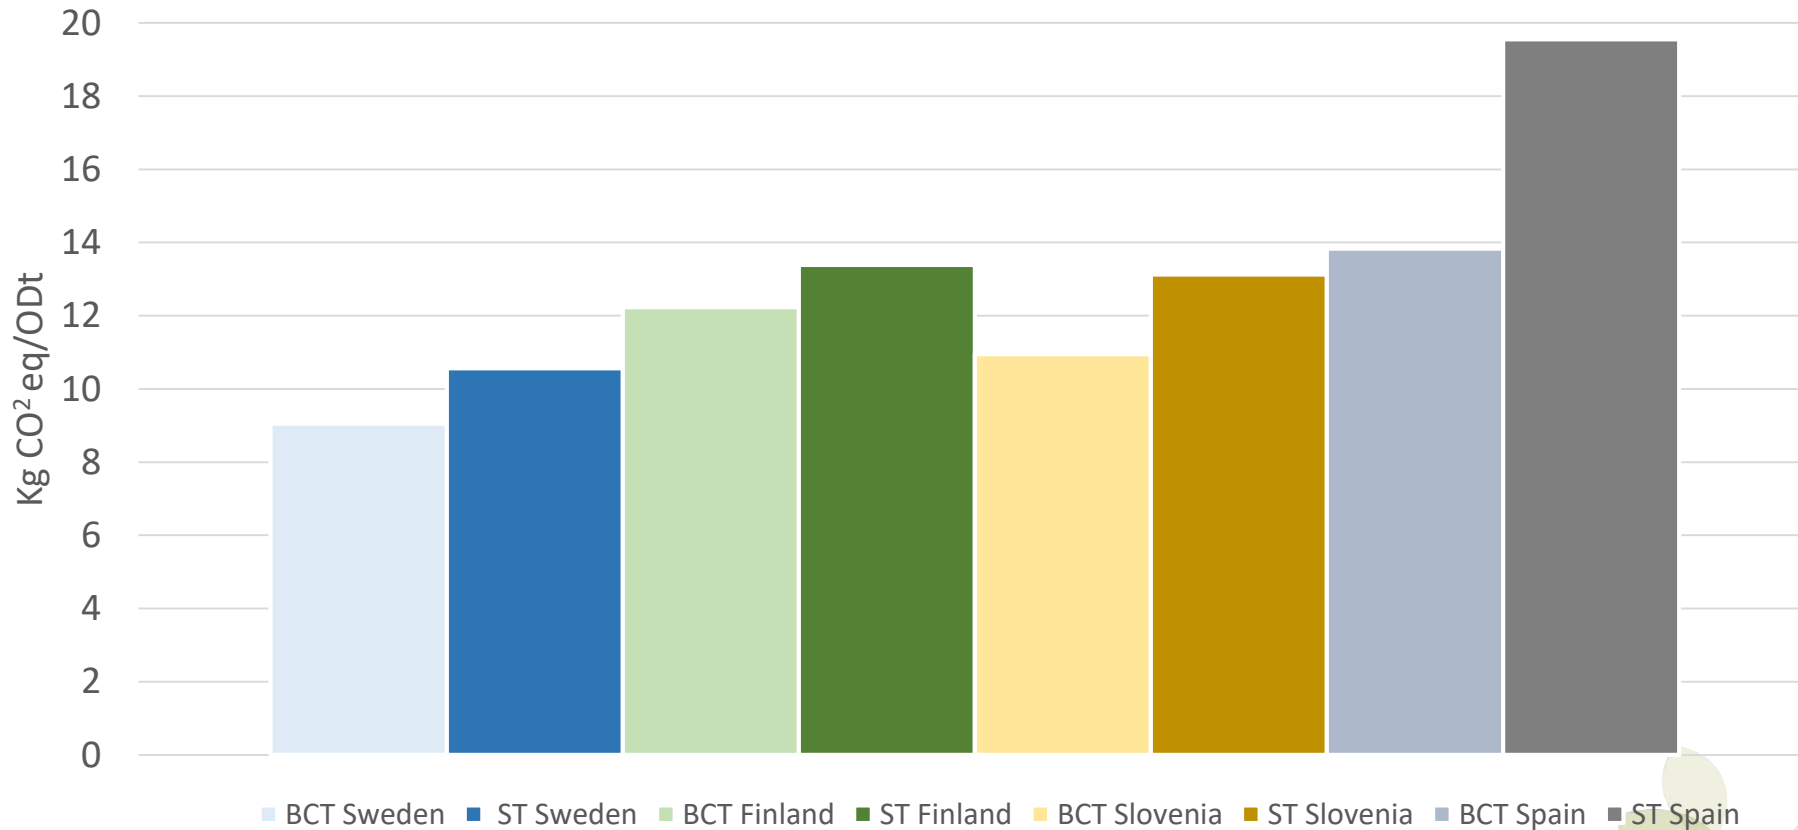
In terms of greenhouse gas emissions, BC harvesting emissions were 14%, 16%, 9% and 29% lower than S harvesting in Sweden, Slovenia, Finland and Spain, respectively.
